Technical Service Bulletin

40 Shock absorber leaks: assessment aid

40 17 70 2018194/8 July 12, 2017. Supersedes Technical Service Bulletin Group 40 number 15-49 dated December 18, 2015 for reasons listed below.

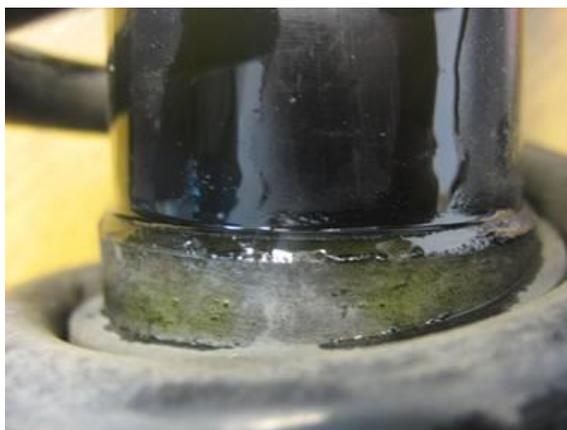
A leaking shock absorber is characterized by a wet film of oil running down the pipe (Figure 1 and Figure 2).

Figure 1. A leaking shock absorber.

Leaking shock absorbers need to be replaced.

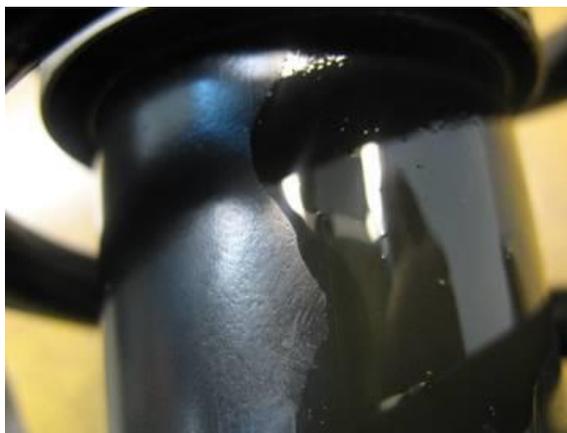
Figure 2. A leaking shock absorber.

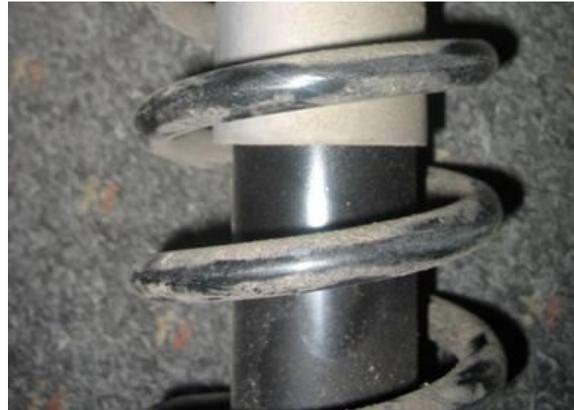
A light film of dried oil or oil marks on the pipe beneath the dust guard are not a clear indicator of a leaking shock. These marks are a result of residue from when the shock was filled during production, or of slight condensation in the seal area. This small amount of oil is for lubrication and it reduces wear on the seal (Figure 3 and Figure 4).

Figure 3. A shock absorber that is not leaking.

This condition does not affect the shock absorber. No repair is necessary.
